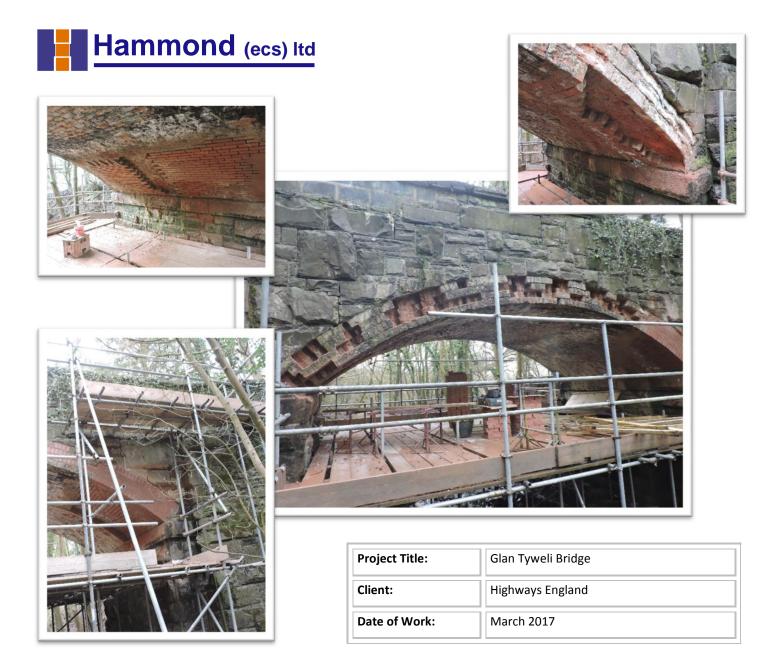
Project Description	<u>Project Constraints</u> Traffic Management.
<u>South voussoir</u> Deeply spalled brickwork in the following areas were cut out and repaired: 1 st ring: 9no, 2 nd ring: 6no, 3 rd ring: 8no, 4 th ring: 16no.	Work at high level. Poor condition of structure. Sourcing bricks of matching size/colour.
<u>North voussoir</u> Deeply spalled brickwork in the following areas were cut out and repaired: 1 st ring: 29no, 2 nd ring: 48no, 3 rd ring: 47no, 4 th ring: 53no.	Public Interface. 3 rd party negotiations (landowners).
Soffit 7m ² of deeply spalled brickwork in the arch soffit were cut out using a temporary centring system supports.	Access constraints. Expertise required for the installation of the proprietary propping system.
<u>Fly tip removal</u> 14no discarded tyres beneath the bridge deck were removed from site and disposed off at a licensed disposal point.	Expertise required to replace overhead brickwork.
