Project Title:	Cwmcerwyn Tunnel Security Fencing
Client:	Highways England
Date of Work:	April 2015

Project Description

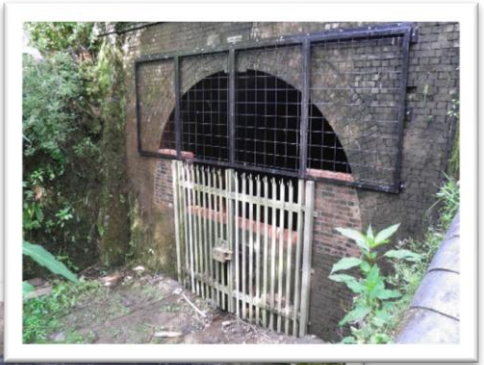
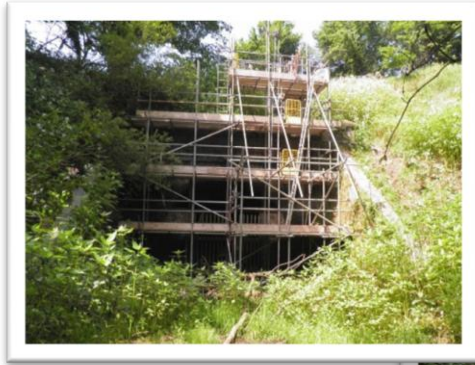
Northwest Portal

A tracked excavator was used to clear a path from the nearest access point to the portal. The tracked had silted up and become very boggy for a distance of 200m. A scaffold platform was erected to provide safe high level access across the portal. The loose staggered brickwork was dismantled and stacked neatly inside the tunnel. The remaining brickwork was modified and a mesh panel installed to close off the void above as per drawing BRB639-0001.

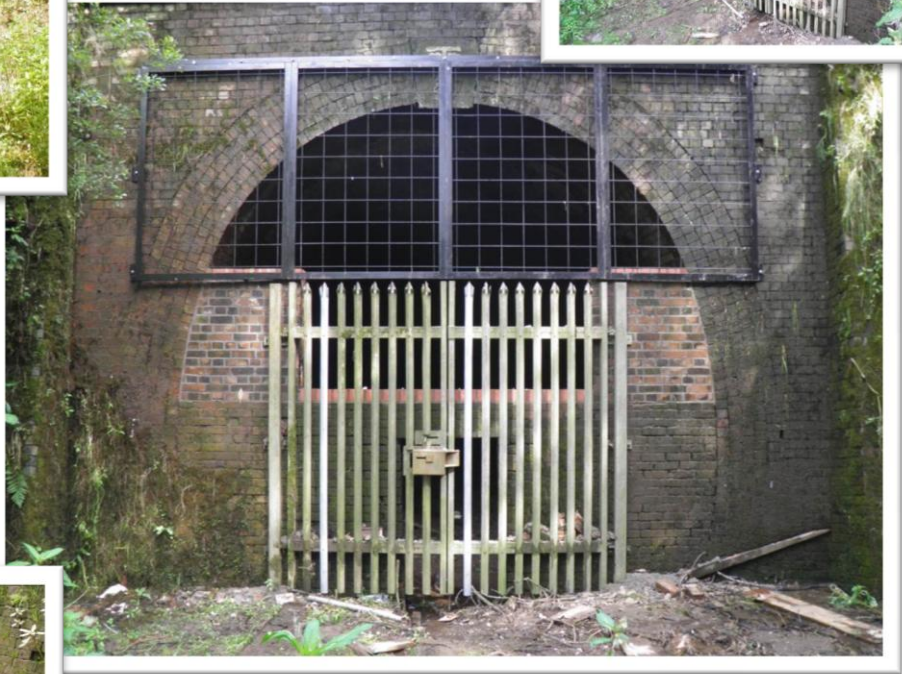
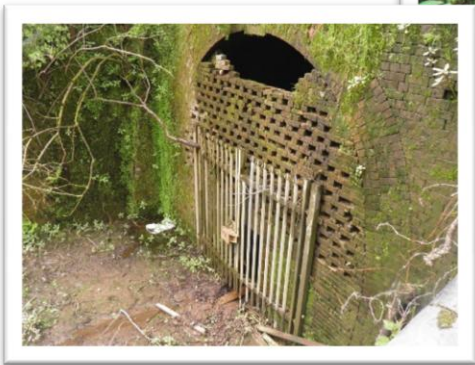
Northwest Portal

Due to the steep embankments around the portal a scaffold platform was erected to provide safe high level access from the farm track down into the trackbed below. The loose staggered brickwork was dismantled and stacked neatly inside the tunnel. The remaining brickwork was modified and a mesh panel installed to close off the void above as per drawing BRB639-0001. Damaged and loose pales were replaced where required.
