| Project Title: | Merthyr Bridge on the Taff Trail |
| Client: | Merthyr Tydfil Council |
| Date of Work: | June 2012 |

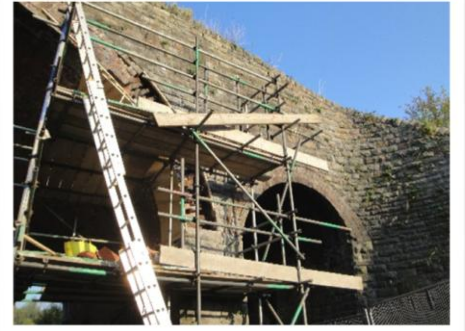
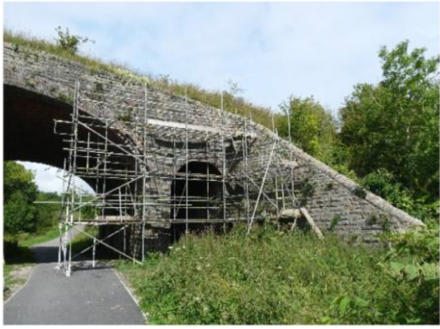
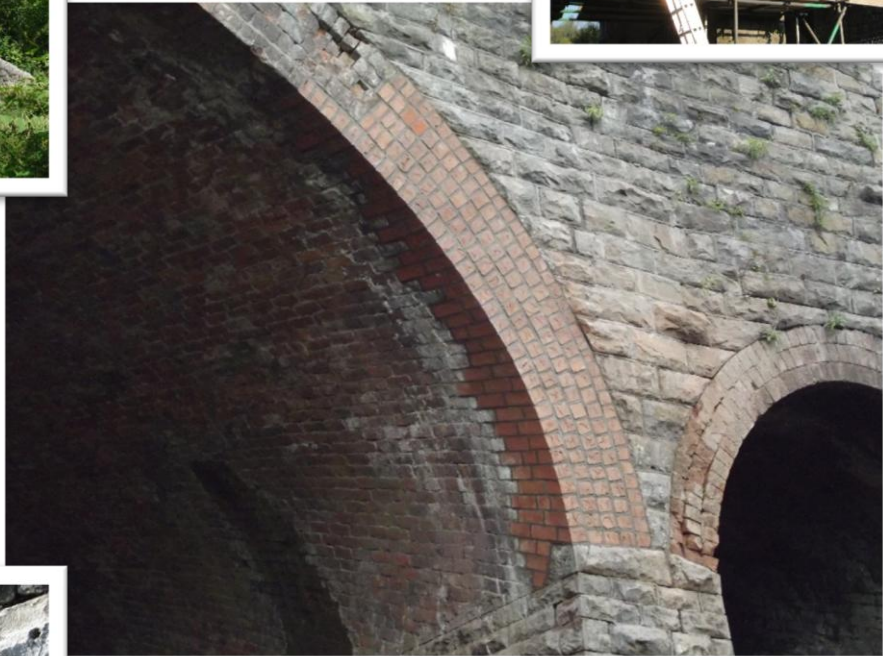
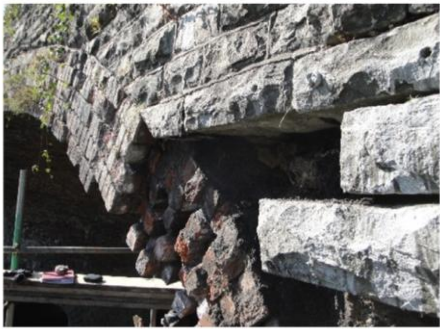
The brickwork in the southeast springing point had perished due to water ingress, leaving the spandrel above unsupported.

The spandrel stonework was dismantled where it had partially collapsed. The remaining undisturbed masonry was pinned. The remaining defective brickwork was cut out and toothed in the springing point. A centring and formwork system was installed and the highly skewed brickwork was rebuilt to match existing.
