Project Title:	Ottertton Bridge
Client:	Highways England
Date of Work:	May 2012

Project description

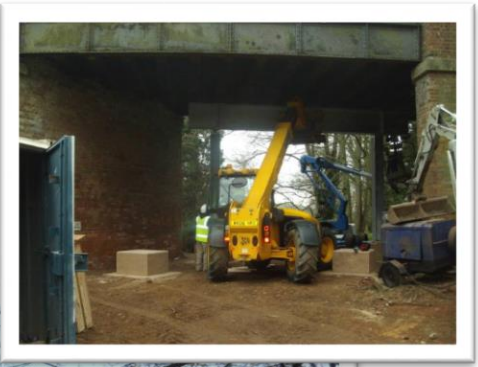
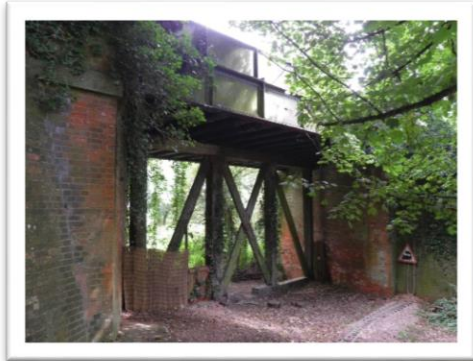
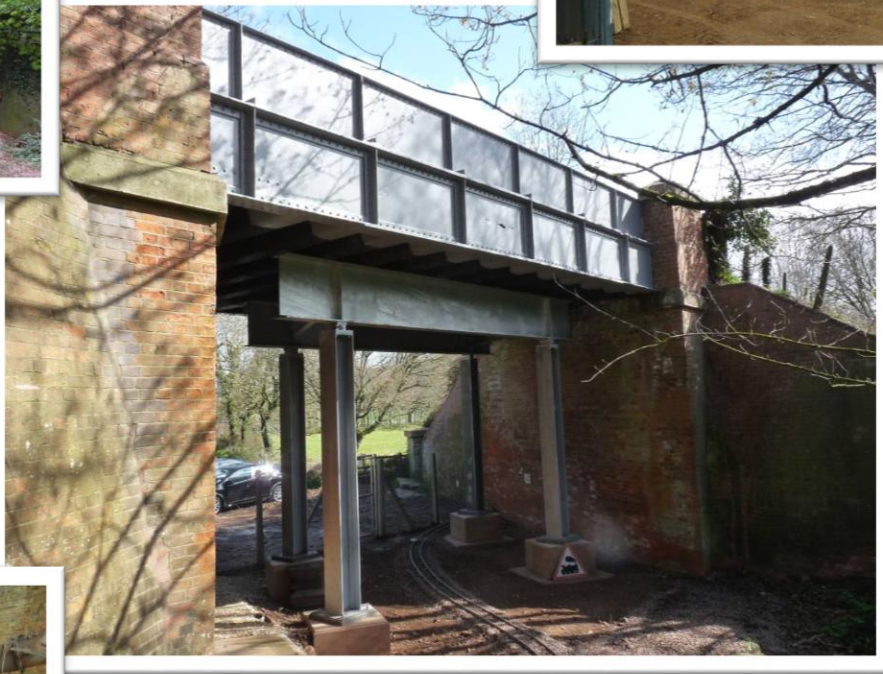
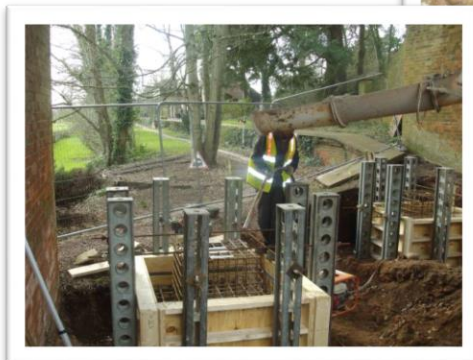
The existing timber propping supporting a disused railway bridge had rotten and settled and left the wrought iron trough decking unsupported.

The steel parapets were also in a poor condition, with rust holes generally over the face of the parapet.

The scheme involved replacing the existing ineffective timber propping system with a galvanised steel propping system supporting the transverse through and reducing the loads imposed on the main girders, repairs to the parapet screens and following vegetation removal undertaking minor brickwork required to the wing-walls.
