Project Title:	Pensford Viaduct Emergency Repairs
Client:	Highways England
Date of Work:	August 2015

Project description

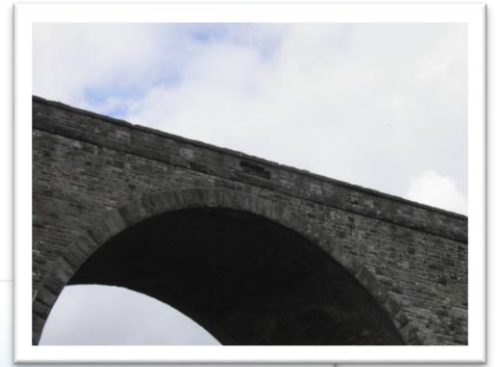
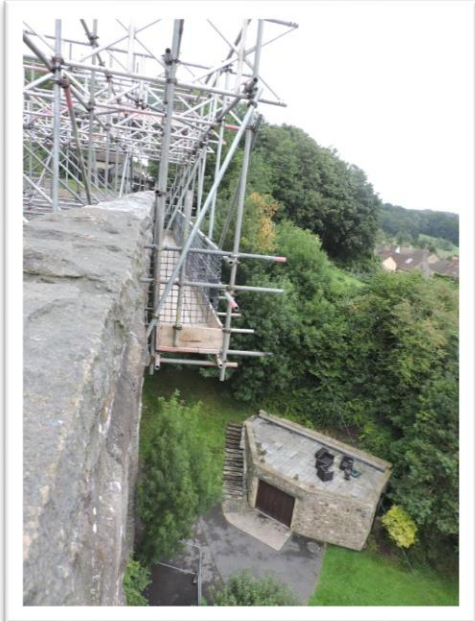
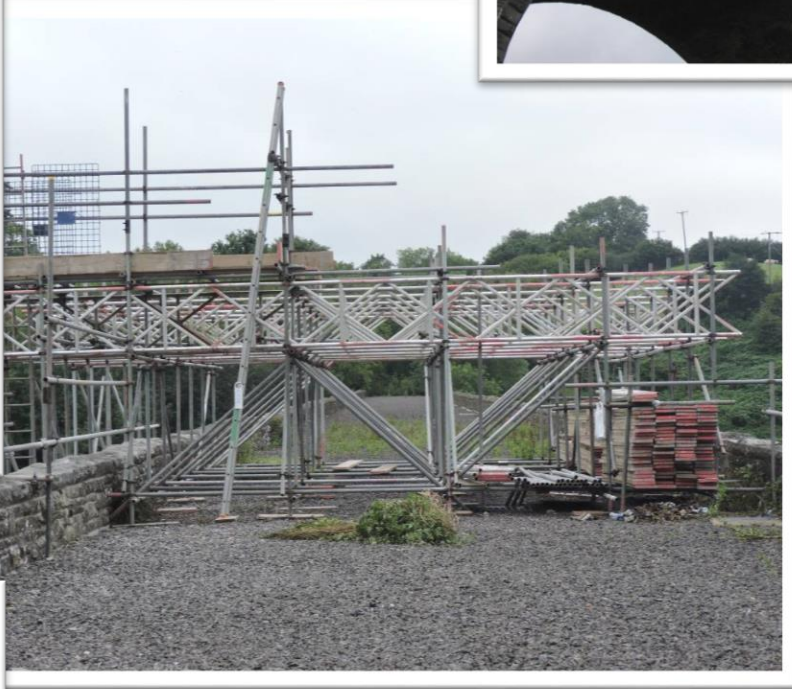
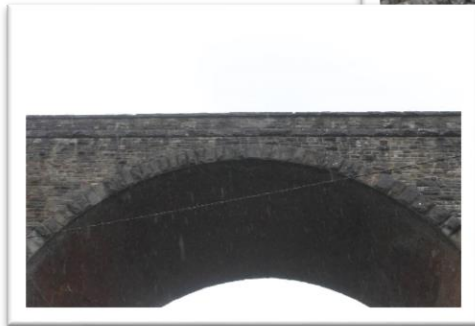
Erected Heras Fencing below span 3 to prevent members of the public and the landowner from walking beneath the area of defective parapet.
 Applied for an emergency footpath closure with Bath and Northeast Somerset Council for the footpath that runs below Span 3.
 Installed temporary track-mats across the garden to provide a suitable access trackway for plant and vehicles from the end of the driveway, across the garden to the north access gates.
 Erected the scaffold platform. Which was subject to Form C Design.
 A tapping survey was undertaken on the section of eastern parapet which had been scaffolded. This confirmed the extent of repair.
 The section of missing masonry in the outside face of the parapet was rebuilt and missing stone imported where necessary.
 The area of parapet that had been scaffolded was re-pointed to ensure its long term stability.
 The joints between the coping stones from the area of repair all the way back to the north access gate was raked out and re-pointed.
