Project Title:	Byfield Road Bridge
Client:	Highways England
Date of Work:	Nov 2011

Project description

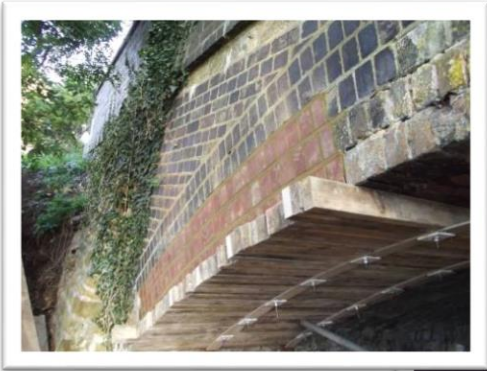
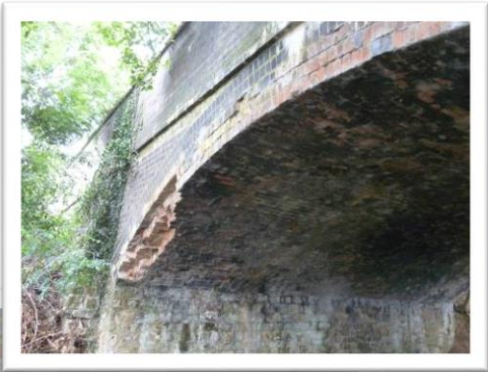
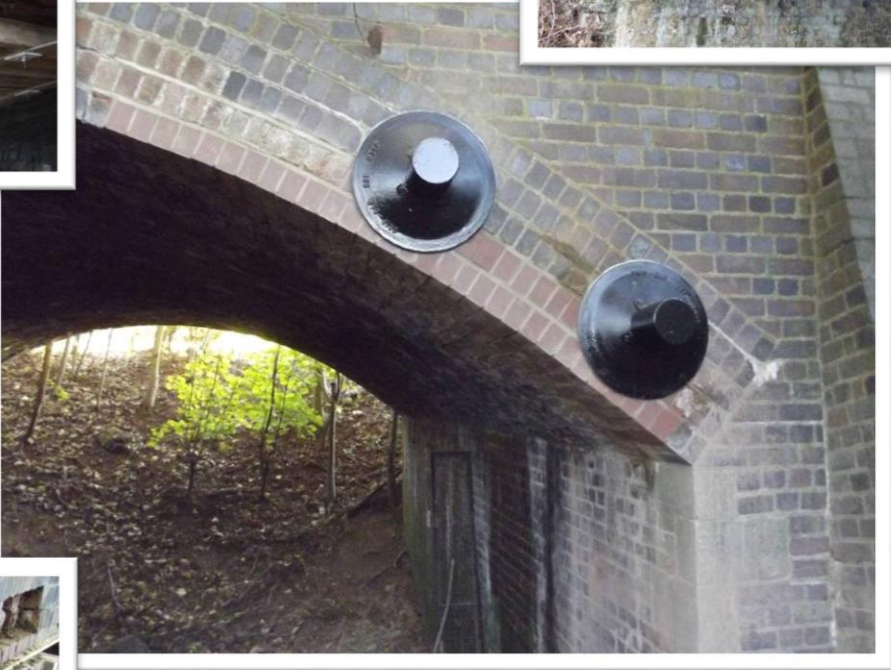
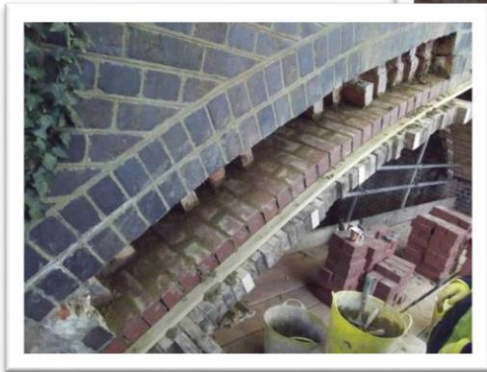
Strengthening, brickwork and re-pointing repairs were carried out to a disused railway bridge, called Byfield Road Bridge. Brickwork had collapsed at the springing point in the 1st, 2nd and 3rd rings.

Northwest springing point - Bricks in the 1st and 2nd and 3rd ring were cut out and replaced at the voussoir/springing point. The removal of the defective brickwork revealed a circumferential fracture running through the 4th ring.

2no 545mm diameter pattress plates and 1200mm long stitching bars (grouted in position) were installed across the area of repair to prevent future movement and fractures.
