Project Title:	Fawley Tunnel
Client:	Highways England
Date of Work:	Jun 2008

Project description

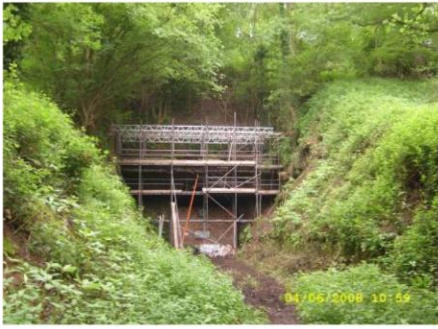
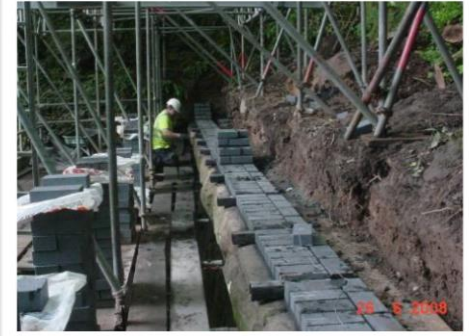
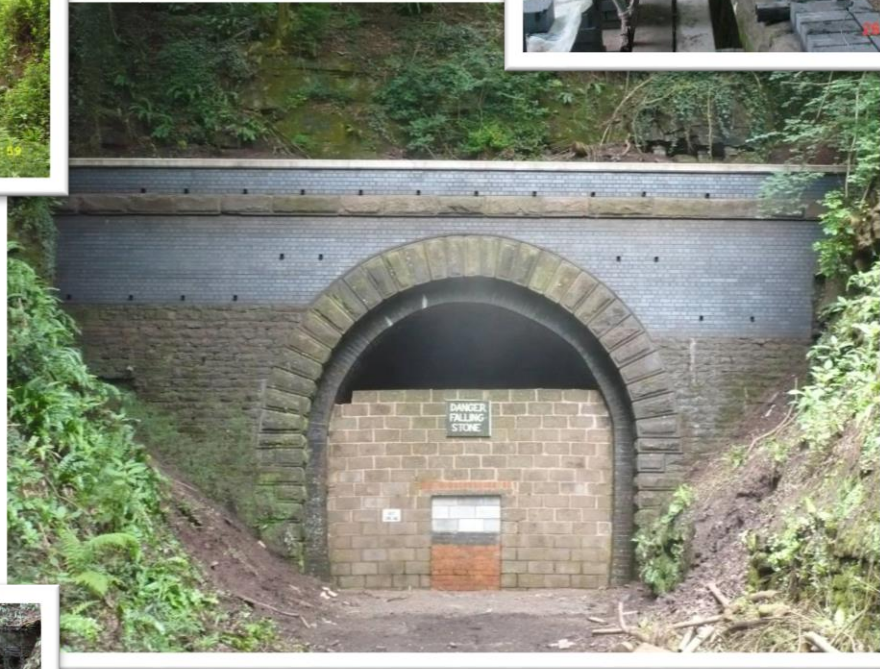
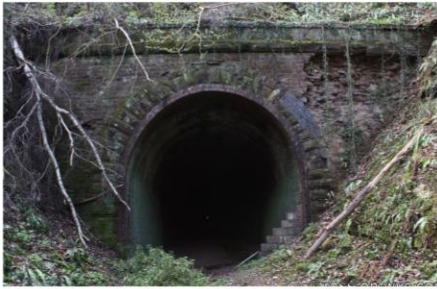
The original scope of works given by the client was to repair areas of bulging masonry in the portal wall. Following the erection of the independently tied scaffolding the true state of the portal was revealed. The masonry had bulged to the point of collapse and the top half of the portal required renewal in brickwork. It was agreed that the reason for the bulging was due to ingress of ground water into the head of the portal from the rock cutting above.

The solution was to carefully dismantle the bulging and spalled masonry. A 1 and ½ brick thick portal was constructed with weepholes. On completion of the brickwork, an in-situ concrete beam was cast along the top of the portal to act as protection from water ingress. The voids behind the brickwork were backfilled with clean drainage stone. To provide a feature and to be sympathetic to the structure, the original masonry stringer course was reinstated.

The outcome is a structure that poses no safety risks to surveyors or members of the public that will require minimal maintenance for the coming years.
