<b>Project Title:</b>	Patchacott Bridge
<b>Client:</b>	Highways England
<b>Date of Work:</b>	Sept 2012

Project description

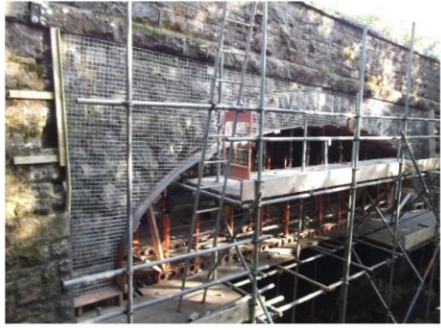
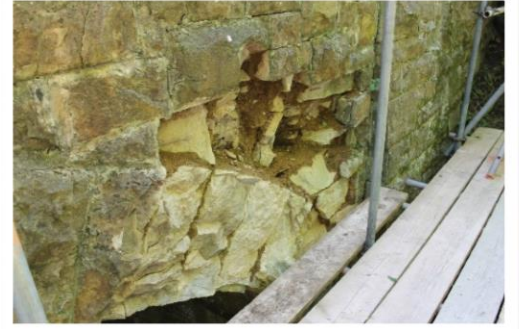
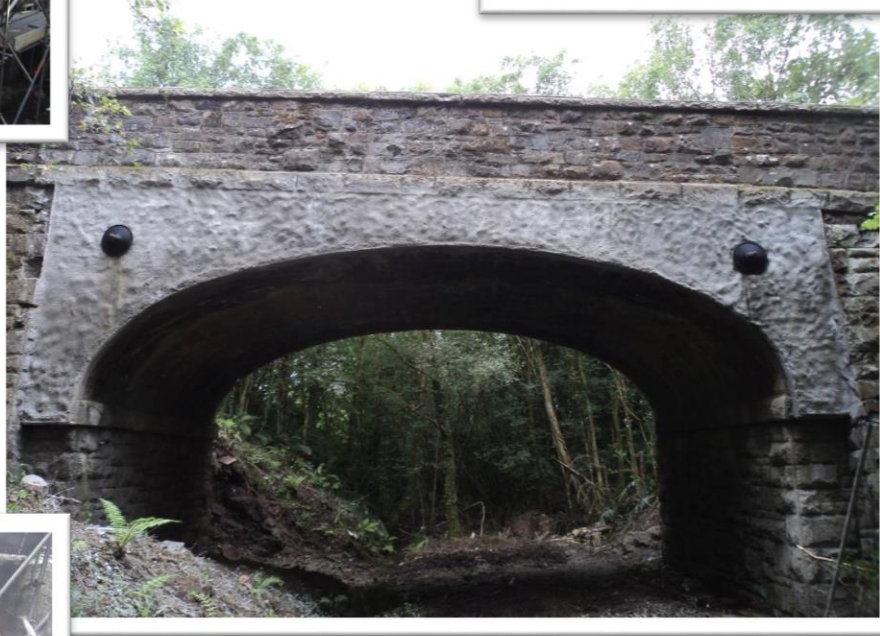
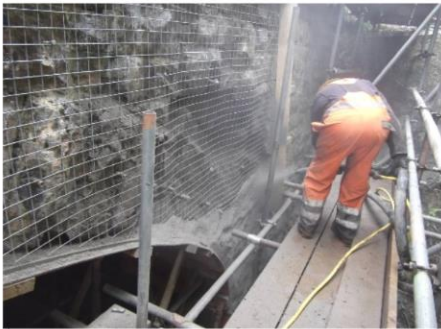
Hammond attended Patchacott Disused Railway Bridge as an emergency to stabilise a large area of collapsed masonry in the spandrel and voussoir following adverse weather.

A full road closure was approved by the local authority and was set up. A scaffold platform was erected beneath the bridge deck. A temporary propping/formwork system was installed beneath both voussoirs. Debris and loose material were removed from both faces of the spandrel and voussoir. 800mm and 1200mm long stitching bars were installed into each voussoir stone, alternating in length and protruded 75mm from the face of the stone. A sprayed concrete render was applied, 100mm thick. 50mmx50mmx10mm weldmesh was installed prior to the spray concrete application. Through ties and pattress plates (420mm diameter) were installed through the spandrel and grouted on completion.
